SPECIAL BOLT & NUT FITTINGS

JUNG
SANG
BOLT
& NUT

CONTENTS

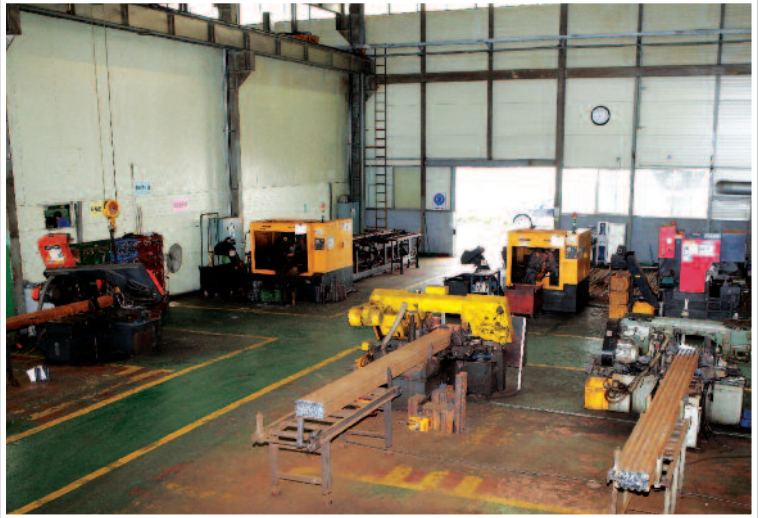
1. Cutting Line

BAND SAW(4)
CIRCULAR SAW(3)

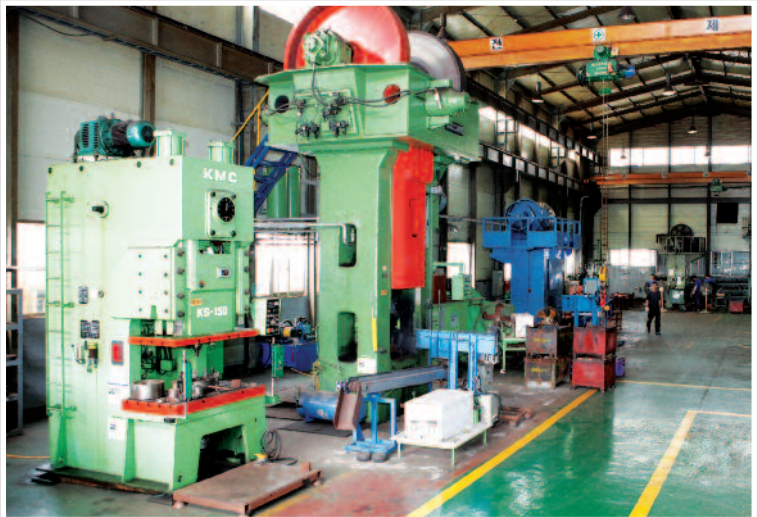
2. Forging Process Line

HYDRAULIC-PRESS(200t other 1)
FRICTION PRESS (1,200t other 2)
POWER PRESS (150t)

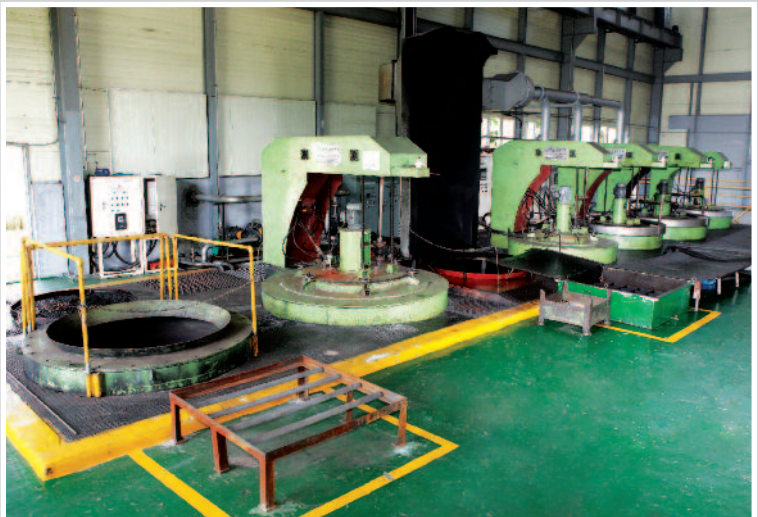
3. Heat Treatment Line

HEATING FURNACE(1)
QUENCHING FURNACE(1)
TEMPERING FURNACE(3)

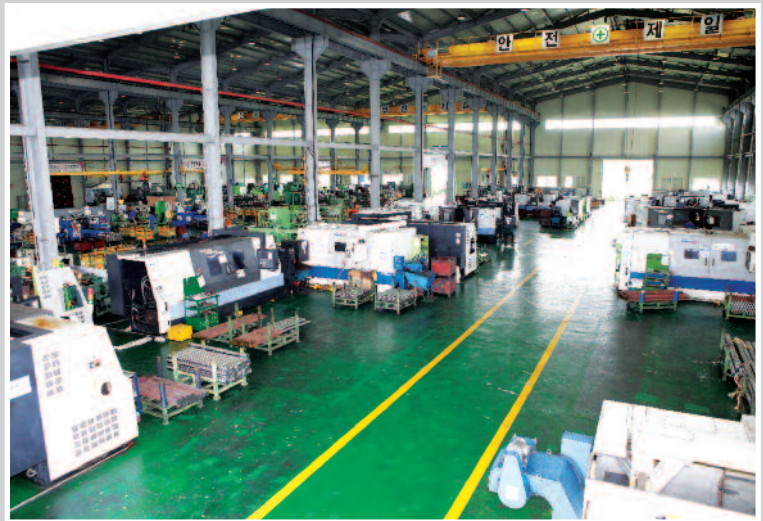
3. CNC Process Line

C.N.C LATHE(PUMA 600L other 31)
HYDRAULIC AUTOMATIC LATHE
CENTERING M/C(2)

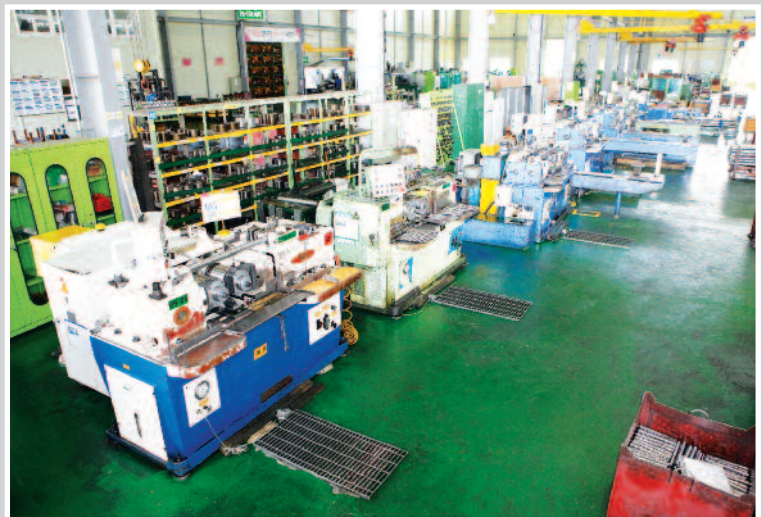
4. Thread Rolling Line

THREAD ROLLING(120t other 15)

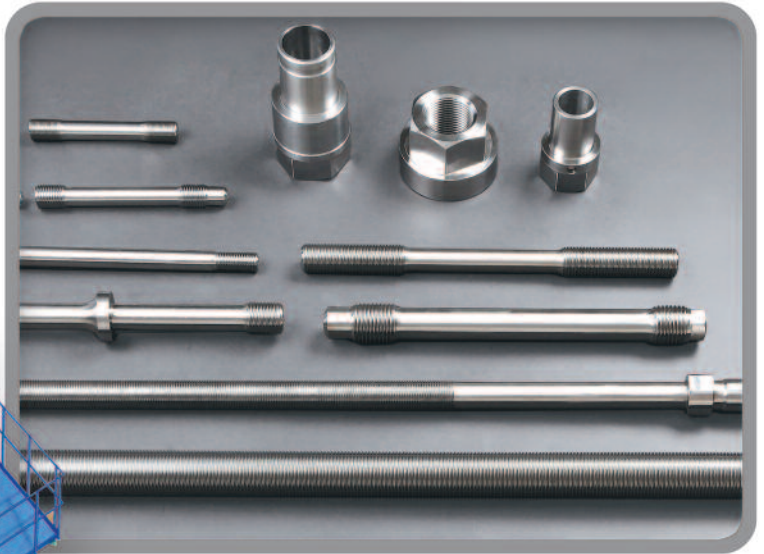
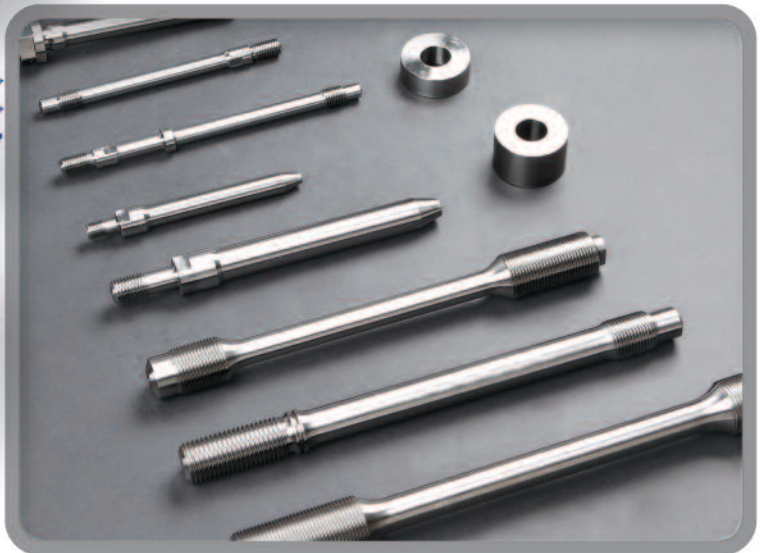
MAN B&W

1. Exhaust Valve Parts

Stud/Hy'd nut for exhaust valve
Used Materials : SNCM439, SCM440

2. Piston Rod part

Used Materials : SNCM439, SCM435, SCM440

3. Special Plug Parts

Used Materials : S45C, SUH3, SUS304,
C3604BD, SUH660, SNB16

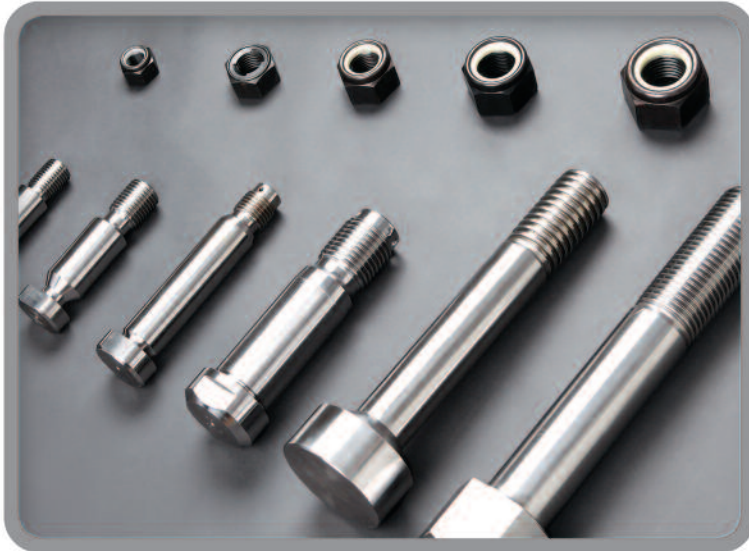
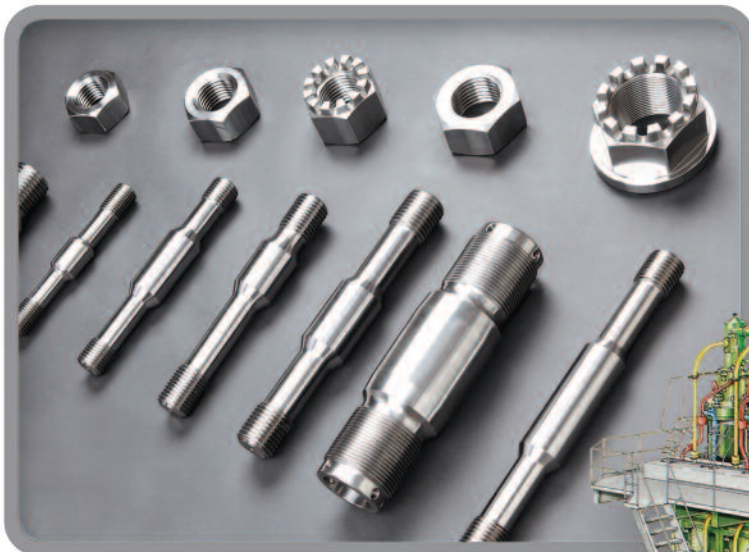
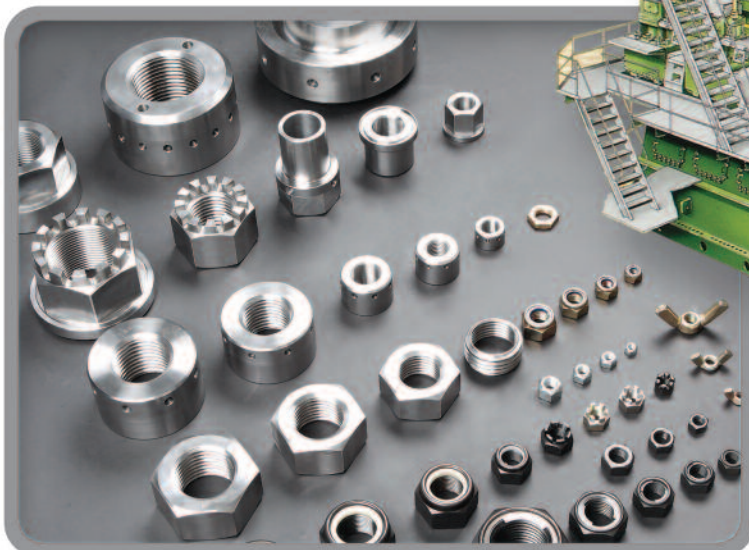
SULZER (9RTA84C TYPE)

- 1. Special Bolt part**
Used Materials : SNCM439, SCM435, SCM440
- 2. Special Fitted Stud part**
Used Materials : SNCM439, SCM435, SCM440
- 3. Special Nut Parts**
Used Materials : SCM435, S45C, SS400

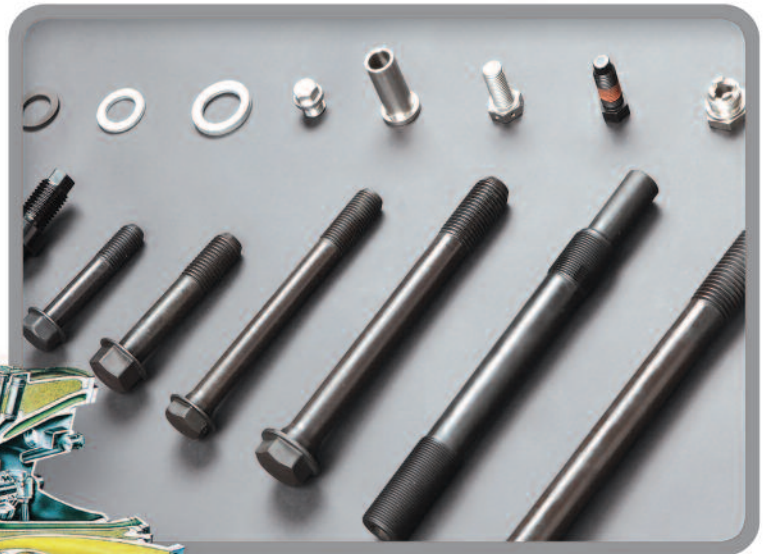
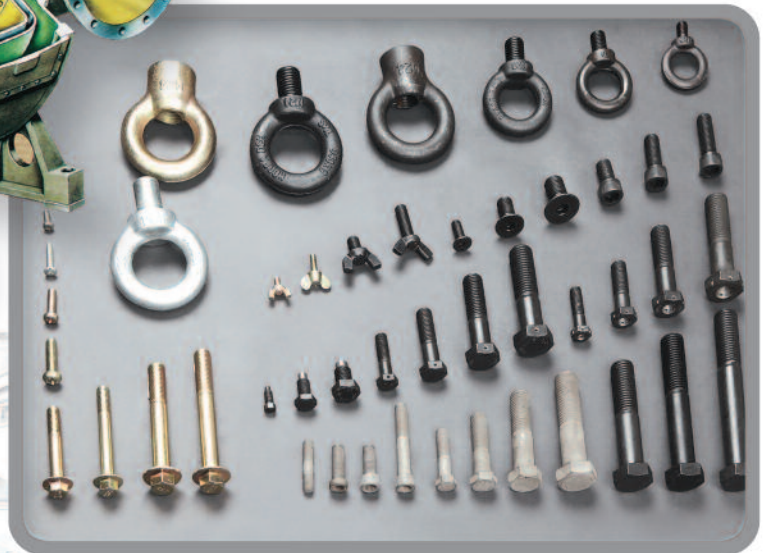
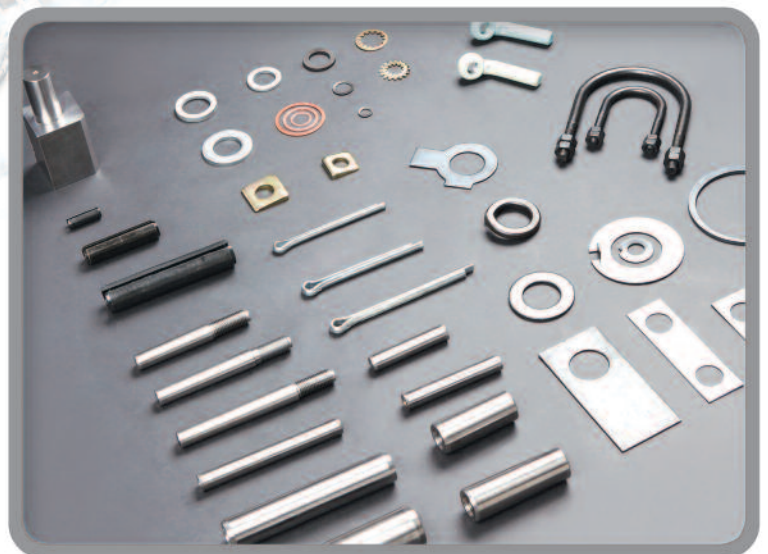
TURBOCHARGER

1. Turbocharger Parts Used

Materials : Ni80A, SUH660, SNB16, SUS316, SUS304, Nitrated Bolt

2. Receiver Parts

Used Materials : SCM435, SS400

3. Special Plate, Pin, U-Bolt, washer Parts

Used Materials : S45C, SS400, SUS304, SUS316

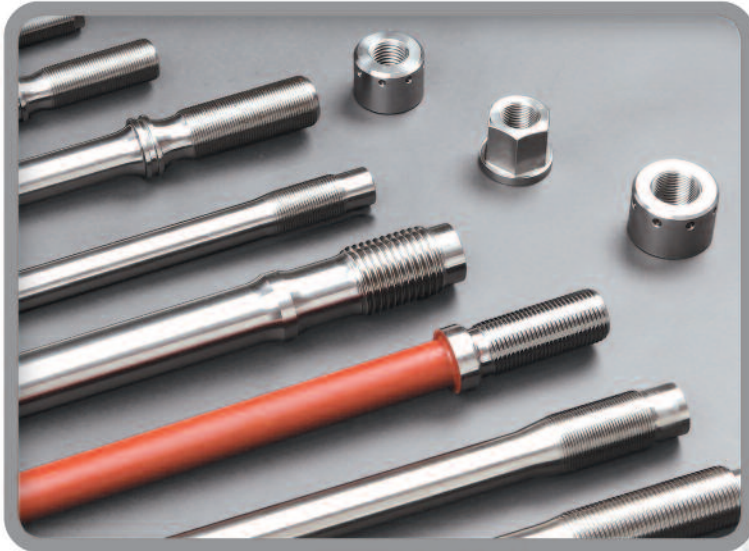
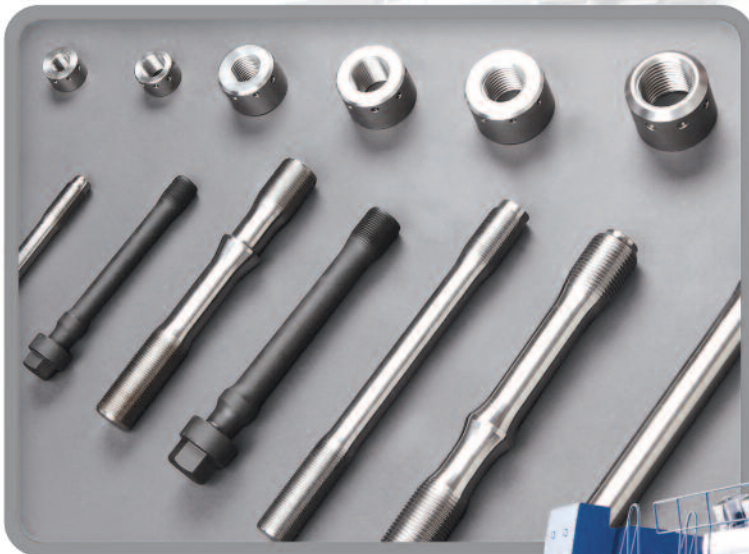
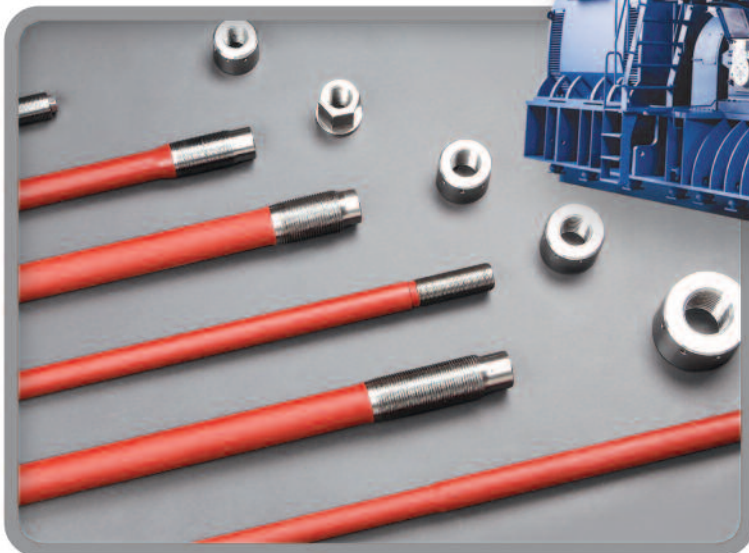
4 Stroke

1. Main Bearing Parts

Stud/Hy'd nut for crank shaft to main bearing cap
Used Materials : SNCM439, SCM435, SCM440

2. Connecting-Rod Parts

Stud/Hy'd nut for connecting rod to bearing cap
(crankpin.crosshead)
Used Materials : SNCM439, SCM435, SCM440

3. Cylinder Cover Parts

Stud/Hy'd nut for cylinder cover
Used Materials : SNCM439, SCM435, SCM440

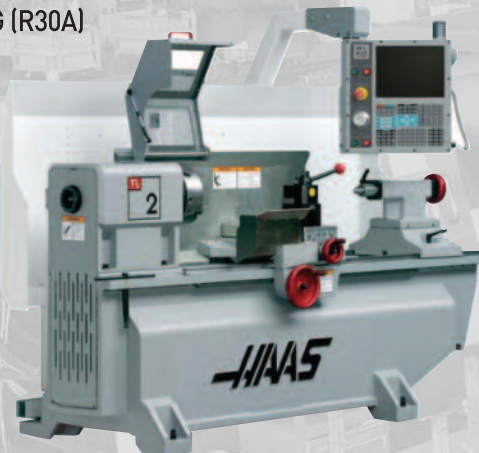
C.N.C LATHE(TL-2)

ROLLING MACHINE HAVING THREE DIES

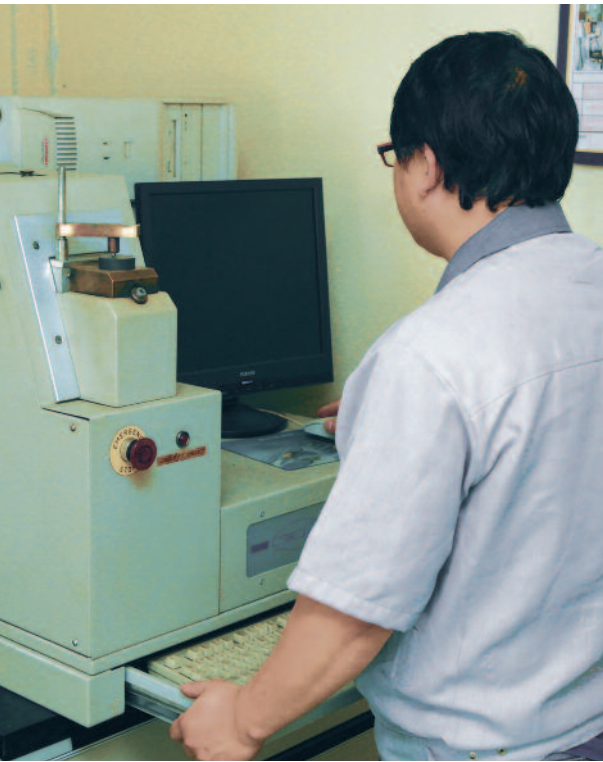
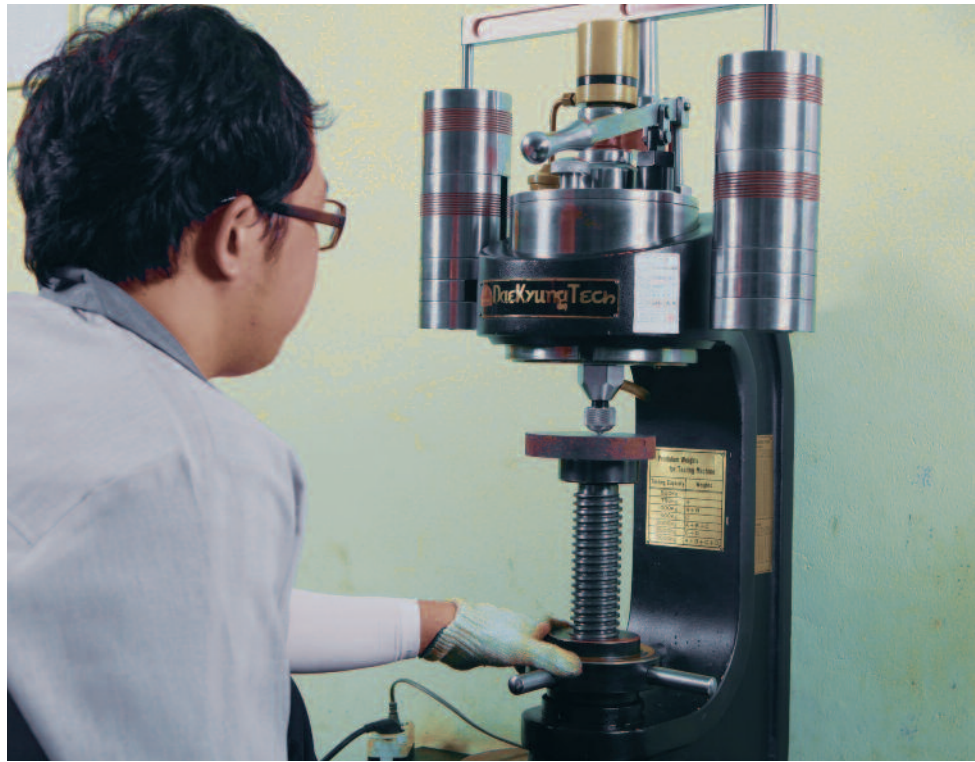
Process to inspect major products

1. Chemical experiment for materials
2. Hardness and tensile strength test after heat treatment
3. Measuring after processing
4. Magnetic particle inspection

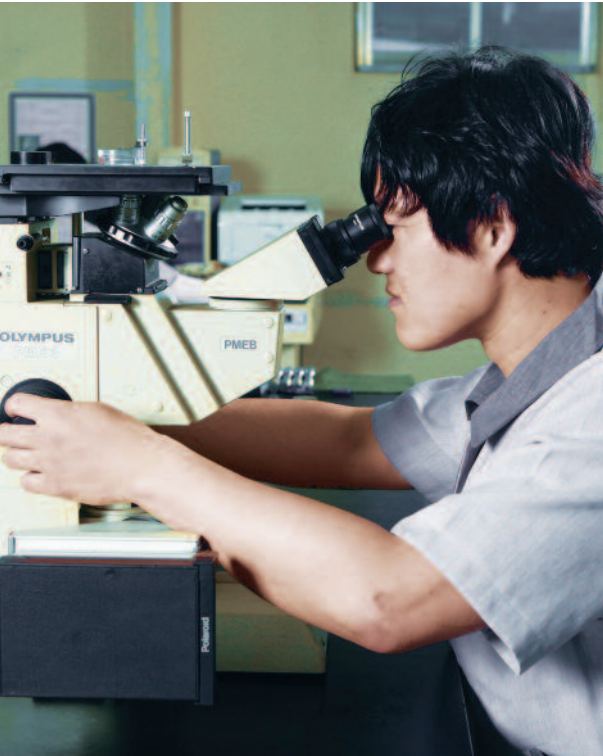
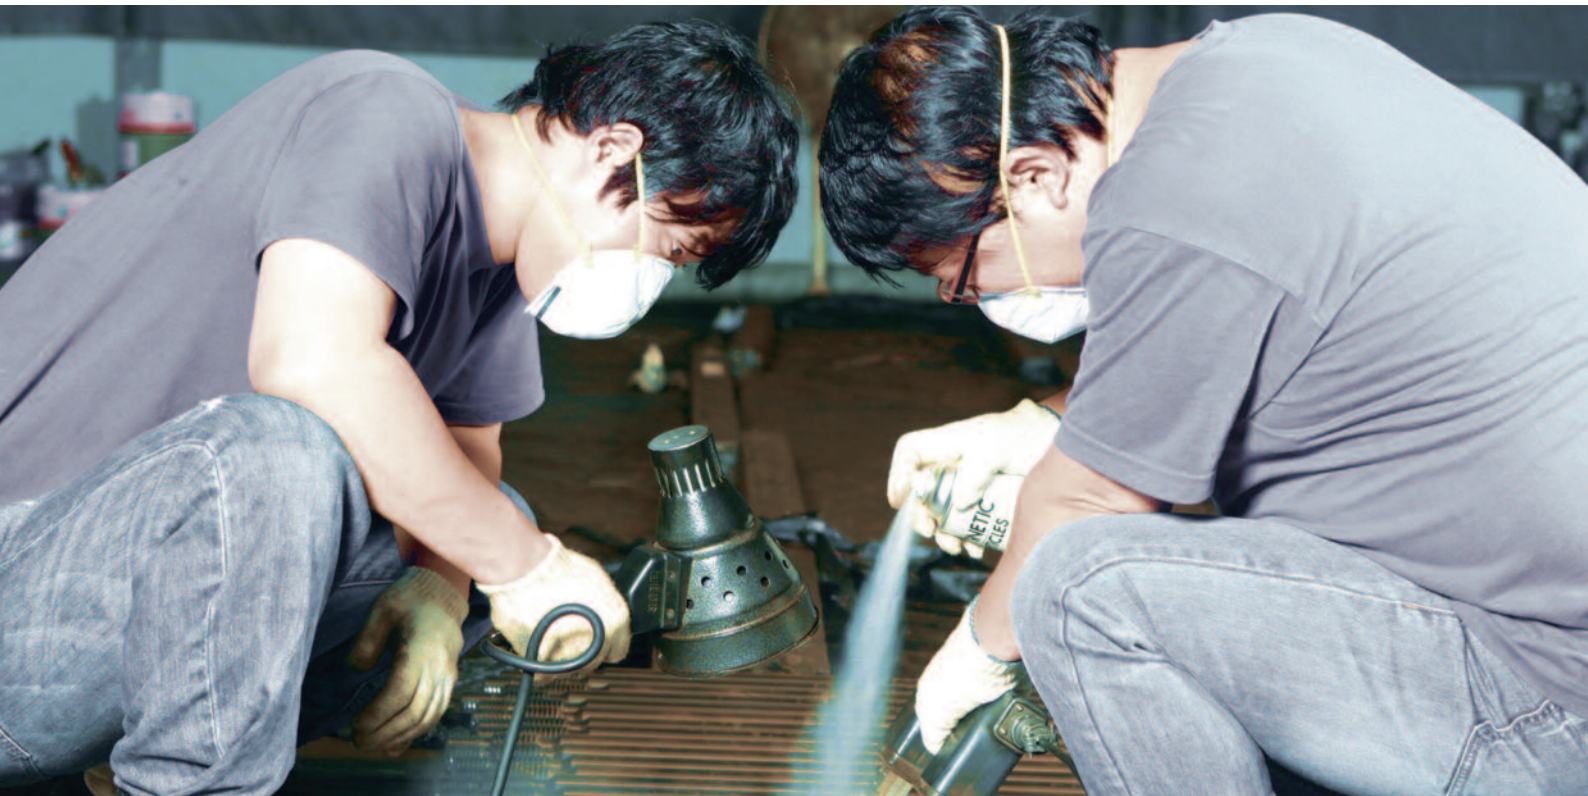
MT Test Report

REPORT OF MAGNETIC PARTICLE EXAMINATION		REPORT OF MAGNETIC PARTICLE EXAMINATION	
JUNGSAN ENTERPRISE CO., LTD.		JUNGSAN ENTERPRISE CO., LTD.	
Client Name	DAEWOO ENGINEERING CO., LTD.	Order No.	2008-0001
Order No.	2008-0001	Material No. & Type	2008-0001
Product Name	STEEL PIPE	Order Date	2008-01-01
Order Date	2008-01-01	Order Qty	1000PCS
TYPE OF MATERIAL			
Material	SA 312 TP 304	Spec. No.	ASTM A 312
Grade	TP 304	Spec. No.	ASTM A 312
Size	1/2" x 1/8"	Spec. No.	ASTM A 312
Heat No.	1000000000	Spec. No.	ASTM A 312
MAGNETIC PARTICLE EXAMINATION			
Method	Wet Fluorescent	Direction	Vertical
Result	No Defects	Inspector	JUNGSAN
